Line – Near Misses

On 5-2-18:

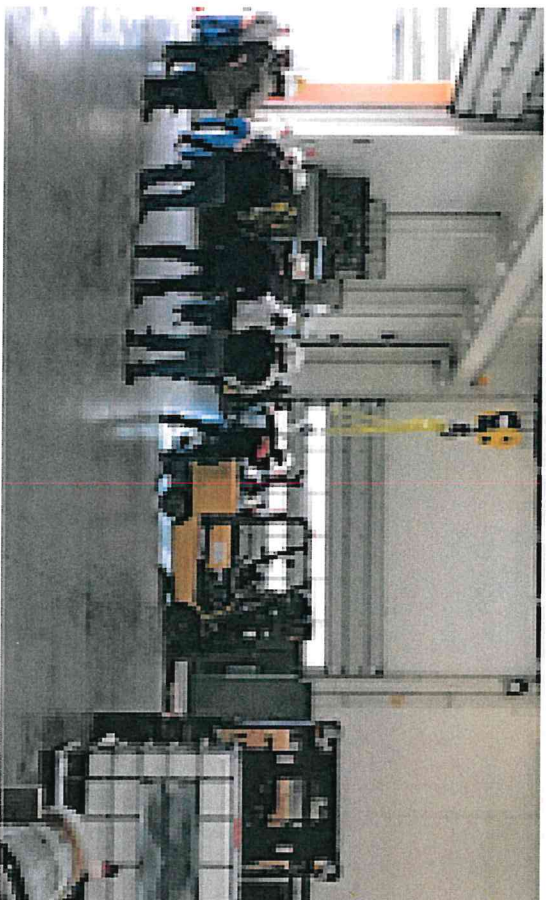
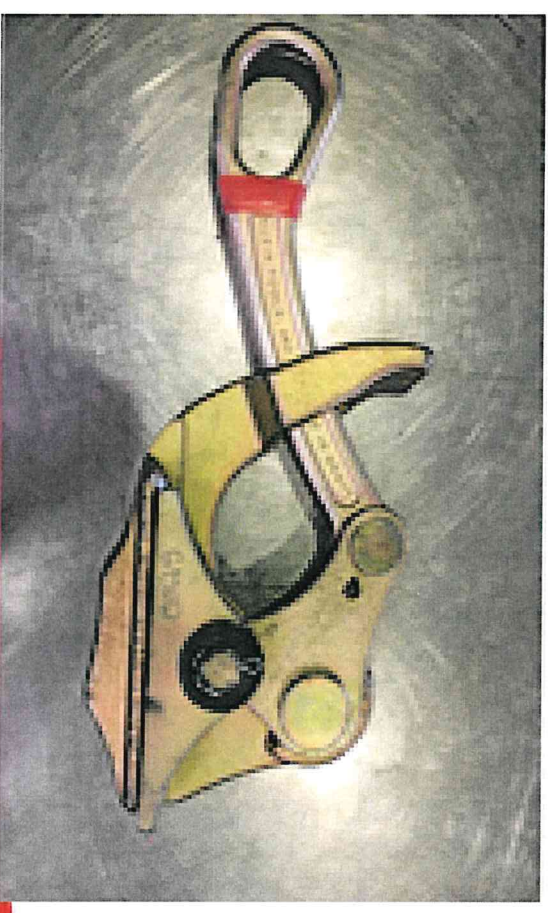
Line & Tool Room tested a Klein 477-954 Grip w/ Dynamometer, pulling 2500lbs strength. Actual grip was used with the same type of wire that crew was pulling.

During the test the grip slipped immediately and no load was measured on dyno. Another Klein 477 grip was placed on wire and it pulled up load with no slip.

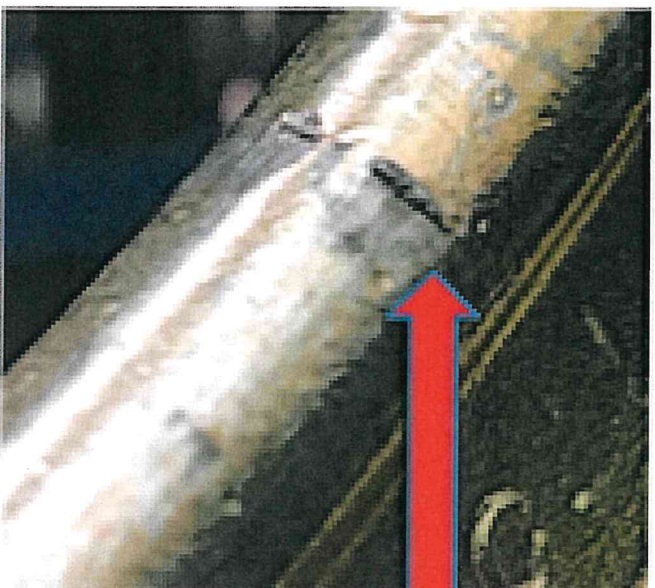
Burr on Slide

Upon further inspection a small burr was discovered on the slide of the grip. This burr would catch and prevent the grip slide from functioning to tighten on the line.

Blue Arrows
Showing Burr and catch area on grip

**Crews to inspect Slide before
use for units in service, return
to Tool Room if found
Tool Room to inspect
inventory for this condition
Klein Rep coming May 21st to
review.**

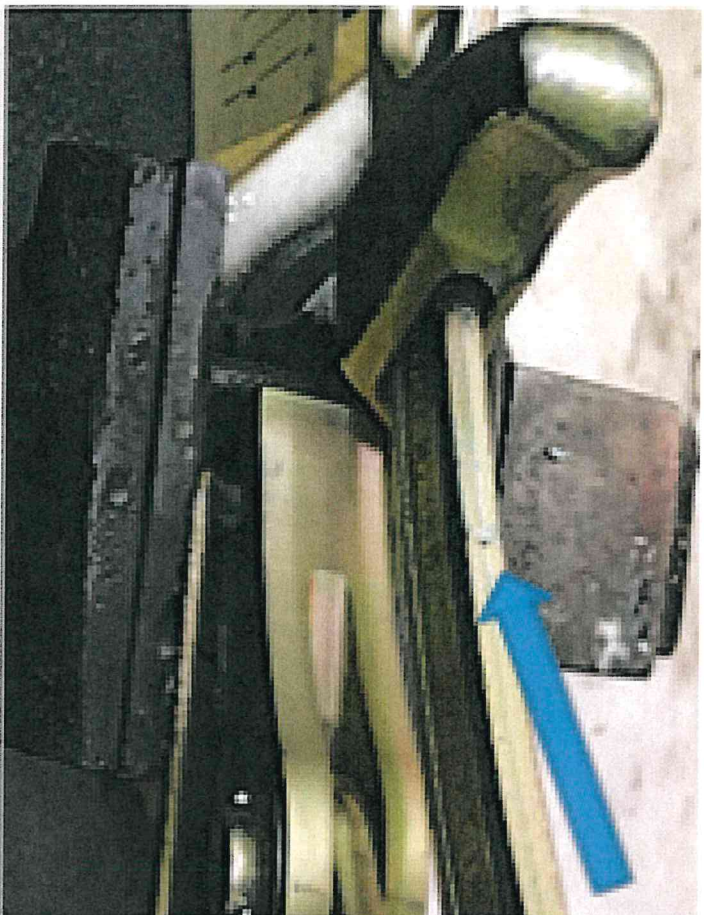
Larger View

Showing Burr and Slide

Note the Size of Burr
